ESTUDIOS SOBRE LA OPERACION Y SEGURIDAD DEL SISTEMA DE EMBALSES DE VALDESIA

FINAL REPORT

VOLUME IV

INSPECTION, MAINTENANCE AND SAFETY STUDIES $\frac{1}{1}$

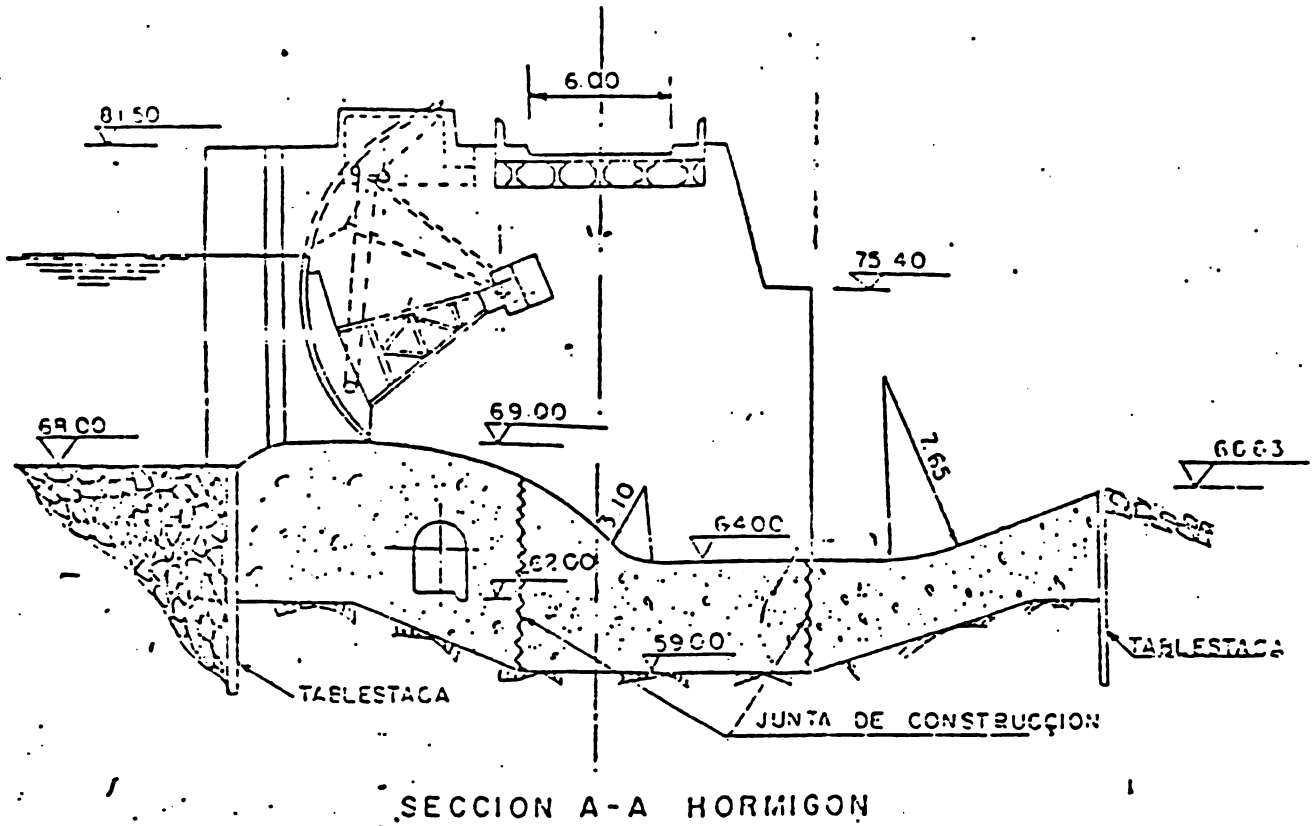
FIGURE 4.7 GATES IN LAS BARIAS AFTER BAY

gates washed away. Spillway gates for the Dam Las Barias were also damaged.

14. An emergency power generator should be installed at the Las Barias spillway to ensure capability to operate the gates.
15. The sump pump in the Las Barias spillway gallery should be maintained in an operable condition so that the gallery can be unwatered for inspection and maintenance of drains.

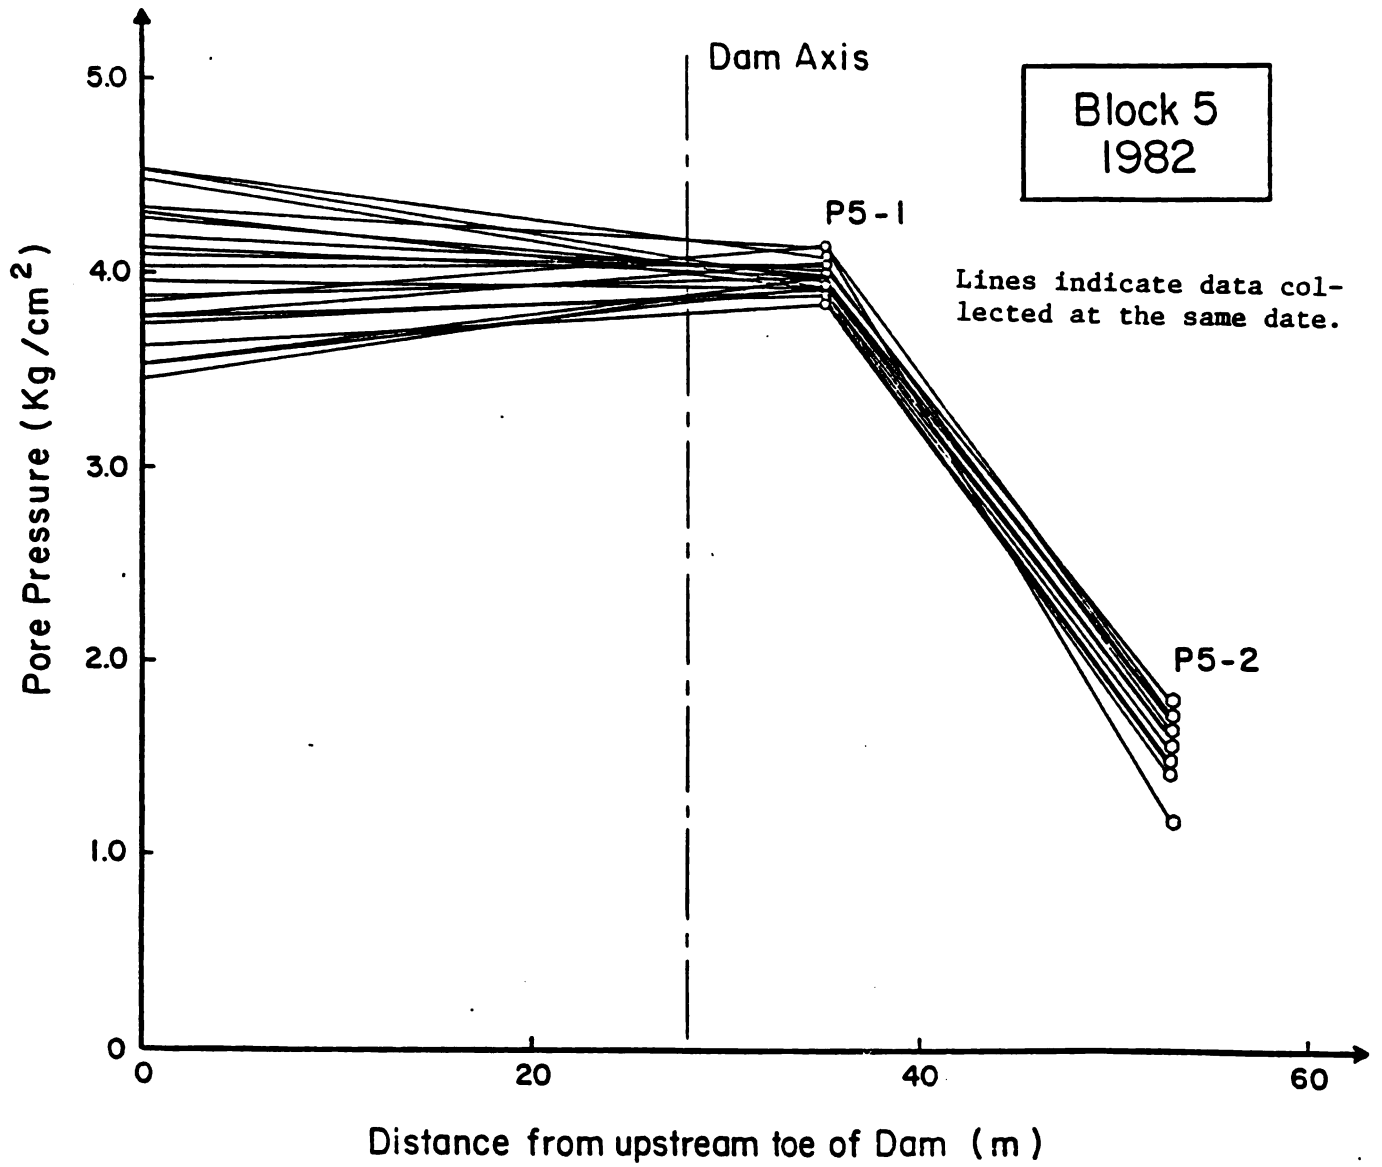
Figure 4.9 - Pore Pressure Distribution for Block 5 - 1982

As stated by Rodriguez, Octavio and Franklin Ramirez in their October, 1985 report titled, "Sistema de Auscultacion de la Presa de Valdesia," that not all the piezometer readings can be trusted. It is recommended that all piezometers should be investigated at once according to the procedure recommended in Section 4.5 of this report. The particular trouble piezometers are No. 1 (P5-1), No. 7 (P17-a) and No. 8 (P17-b) because these readings did not respond to the change of reservoir level (see Figures 4.11 and 4.18). Piezometers No. 4 (P11-2) gave constant pore pressure readings which might be valid. If all the existing piezometer data should be correct; uplift pressure underneath

As discussed in Section 4.5, piezometer P5-1 did not function properly. A check should immediately be made of the piezometric P5-1 to determine if the measurements being obtained are accurate. This can be

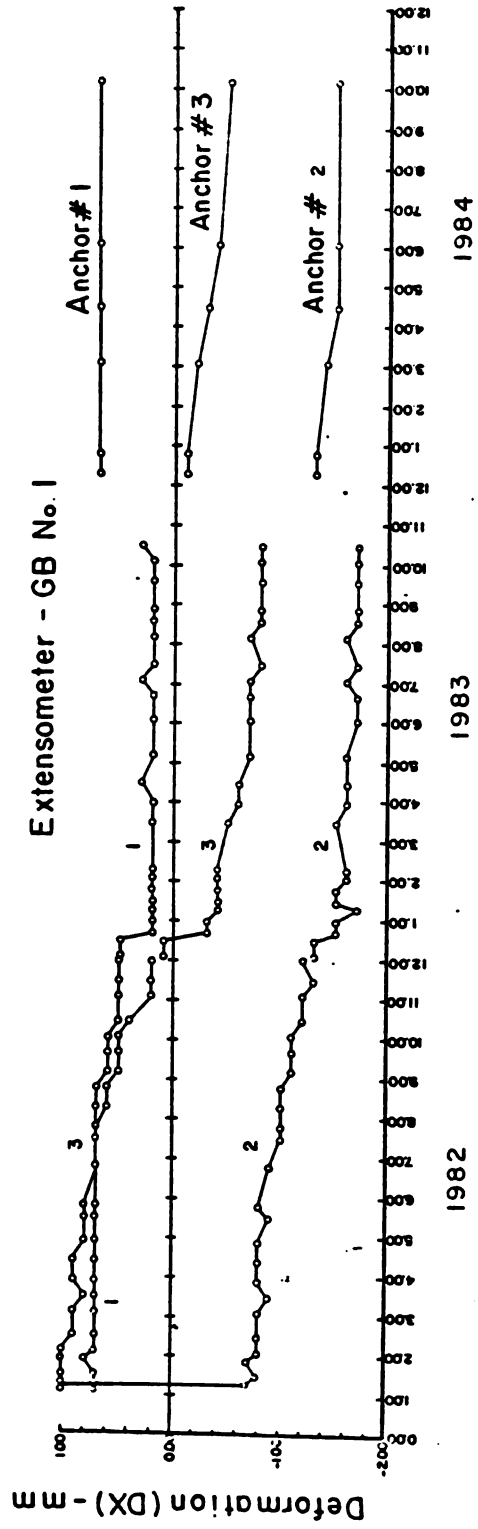
Figure 4.27. Deformation (DX), Extensometer GB No. 1, 1982-1984.

in bad shape during the flooding by Hurricane David and repairs were made for all these extensometers. Data collected during 1982, 1983 and 1984 are plotted in Figs 4-27 through 4-34 and summarized in Table 4.1.
