ESTUDIOS SOBRE LA OPERACION Y SEGURIDAD DEL SISTEMA DE EMBALSES DE VALDESIA

SECOND TECHNICAL REPORT ^{1/}

VOLUME IV

INSPECTION, MAINTENANCE AND SAFETY STUDIES

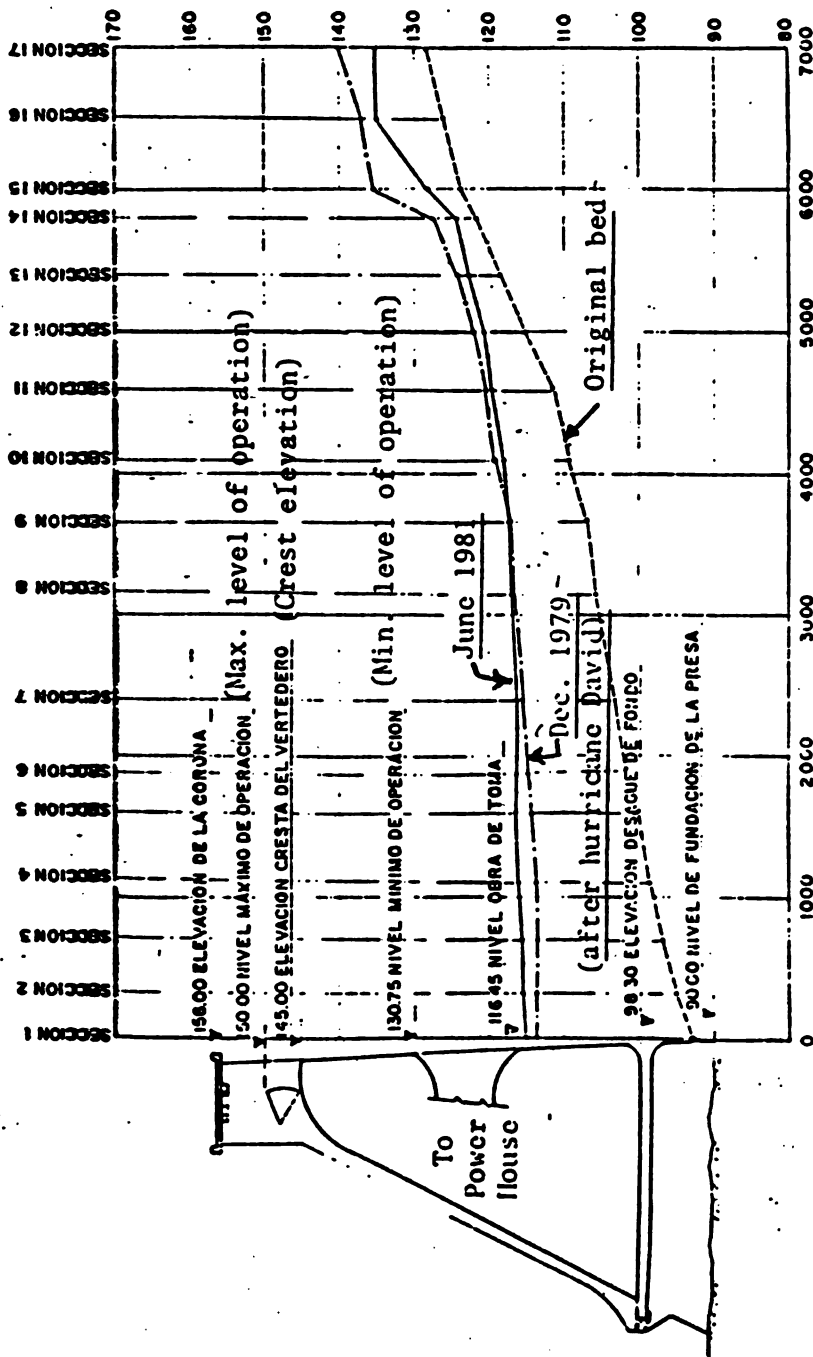
FIGURE 4.8. SEDIMENT DEPOSITION IN VALDESIA

A large volume of sediment was deposited in Valdesia Reservoir during Hurricane David. A sediment survey made in December 1979 indicated that the top of the sediment deposit was near the bottom of the power intake. Most likely, a substantial amount of fine suspended sediment passed through the turbine unit which was in operation during the first part of the hurricane. Later inspection indicated that this sediment did not damage the turbine runner. A contract has been signed to remove much of the deposited sediment by dredging operations. Sediment deposits should be monitored carefully, particularly after each large flood, and removed when necessary to insure that coarse sands and gravels do not pass through the low level outlets and power intake.

16. At Las Barias Dam, reservoir sedimentation should be monitored to insure that large quantities of coarse sediment do not pass

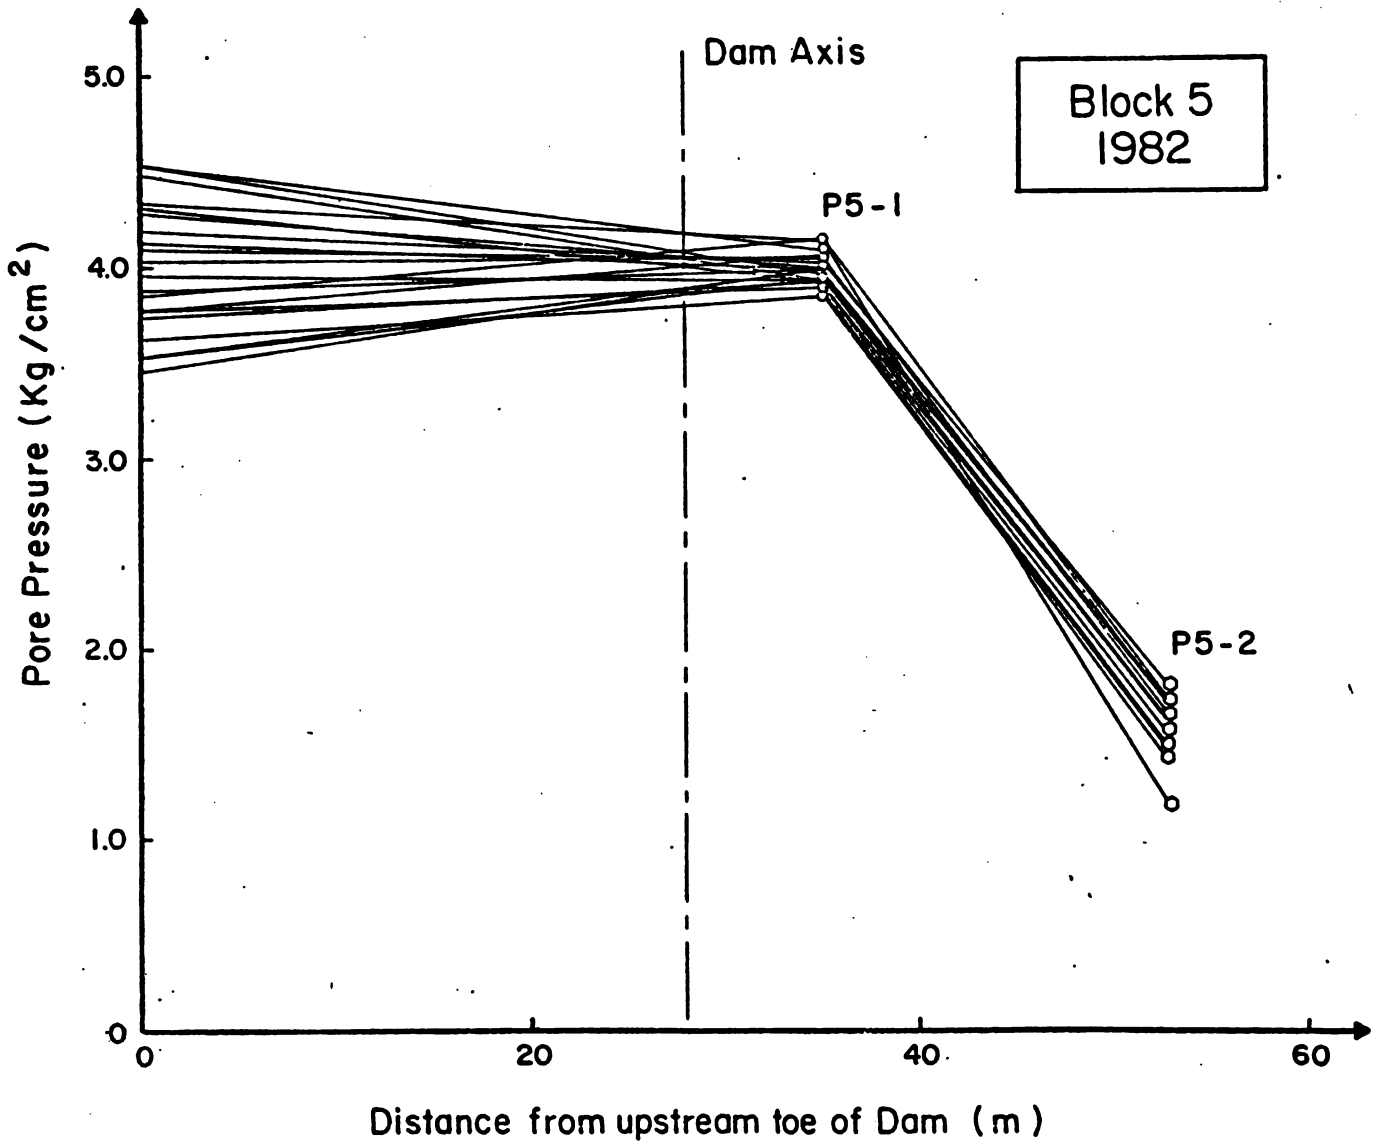
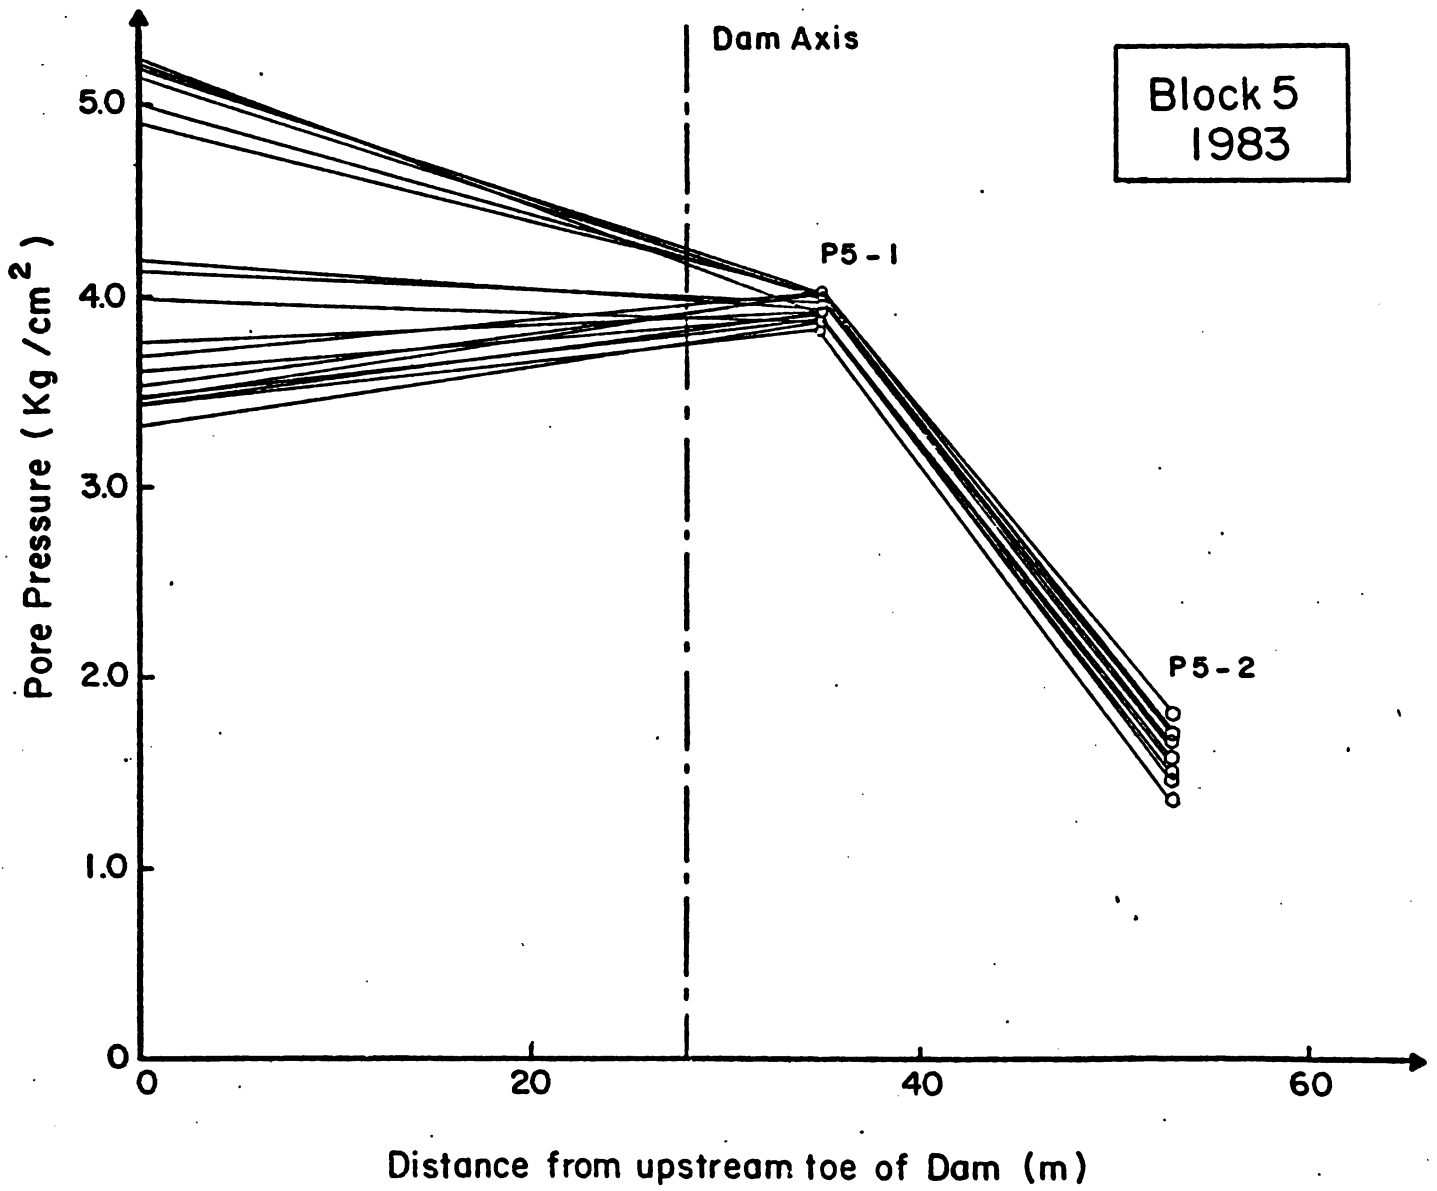
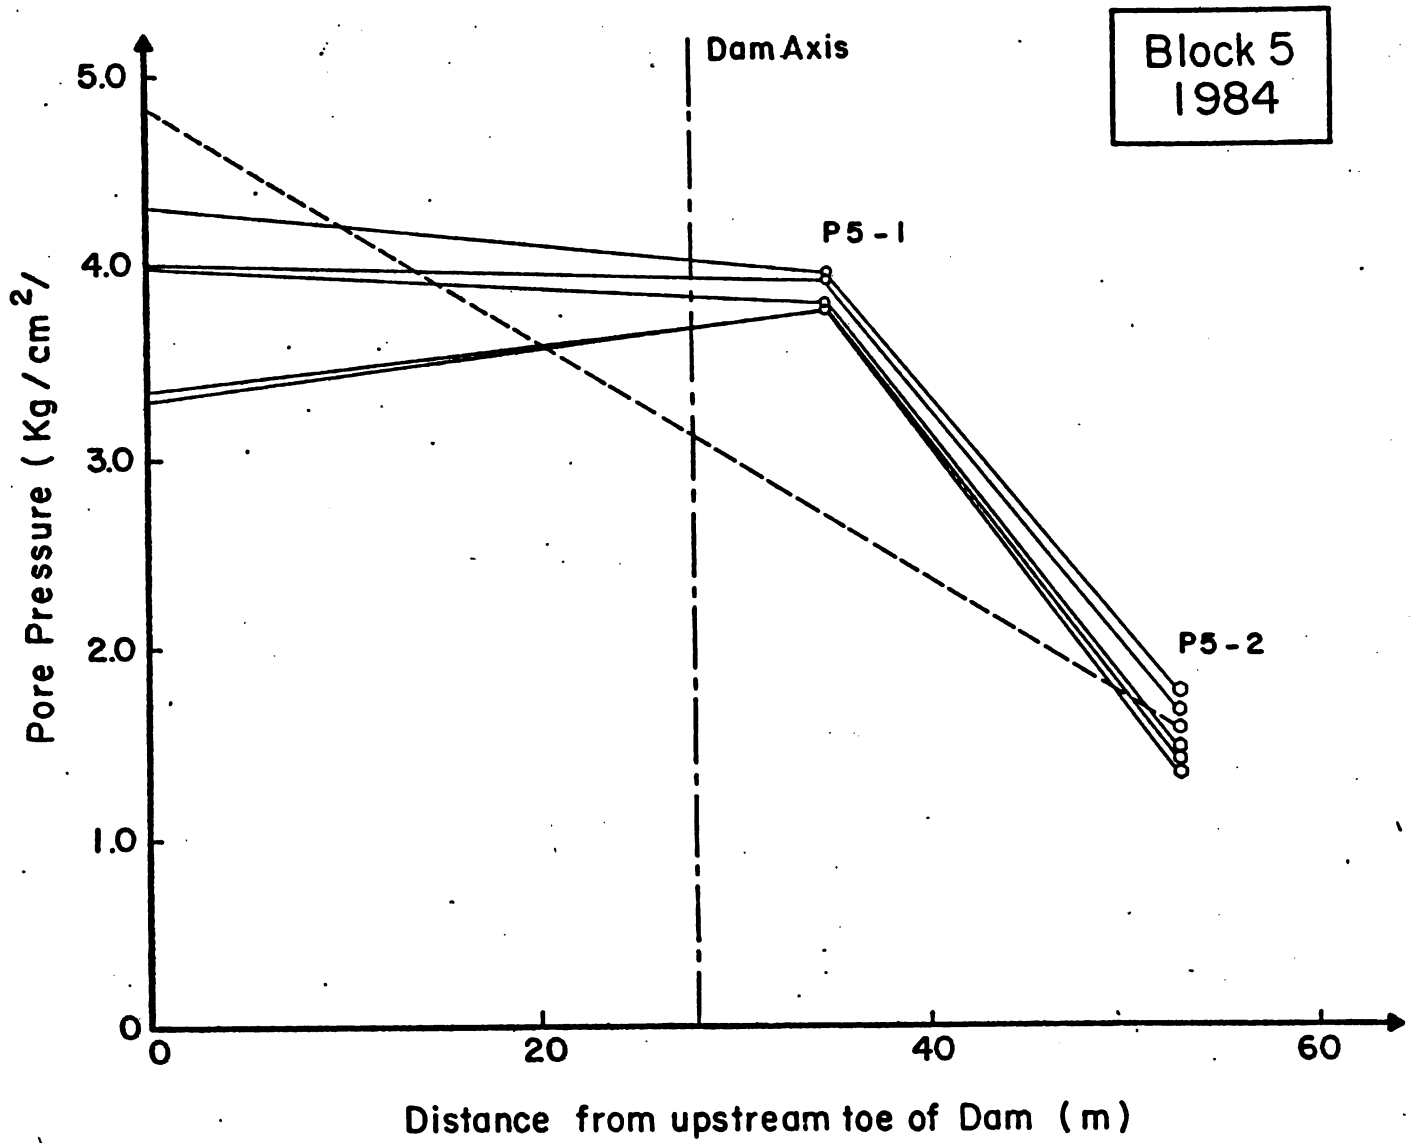
As stated by Rodriguez, Octavio and Franklin Ramirez in their October, 1985 report titled, "Sistema de Auscultacion de la Presa de Valdesia," that not all the piezometer readings can be trused. It is recommended that all piezometers should be investigated at once according to the procedure recommended in Section 4.5 of this report. The particular trouble piezometers are No. 1 (P5-1), No. 7 (P17-a) and No. 8 (p17-b) because these readings did not respond to the change of reservoir level (see Figures 4.11 and 4.18). Piezometers No. 4 (P11-2) gave constant pore pressure readings which might be valid. If all the existing piezometer data should be correct; uplift pressure underneath

10. A study should be performed to assess the adequacy of the existing foundation drainage system at Valdesia.
11. The piezometer system should be investigated to determine if the measurements being obtained are accurate. All piezometers and other measuring devices should be checked at three to four month intervals to assure that they are operating properly.

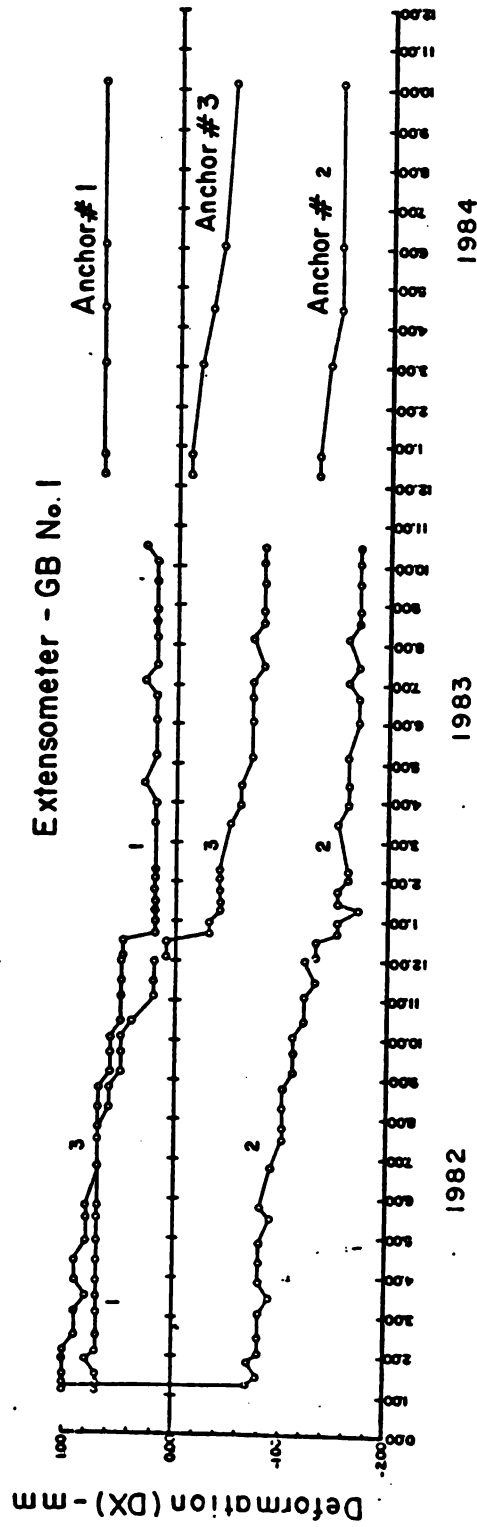
Figure 4.27. Deformation (DX), Extensometer GB No. 1, 1982-1984.

in bad shape during the flooding by Hurricane David and repairs were made for all these extensometers. Data collected during 1982, 1983 and 1984 are plotted in Figs 4-27 through 4-34 and summarized in Table 4.1.

As indicated in Table 4.1, the anchors in Base No. 1 moved within 1 mm; the anchors in Base No. 2 moved within 3 mm; the anchor in Base No. 3 moved within 0.5 mm and the anchor in Base No. 4 moved within 2 mm. These movements appear to be normal. Readings taken from extensometers Group No. 11 installed in the upstream face of dam shell near elevation 116 meters indicated that very little movements occurred between January 1982 and October 1983.
