ESTUDIOS SOBRE LA OPERACION Y SEGURIDAD DEL SISTEMA DE EMBALSES DE VALDESIA

FINAL REPORT

VOLUME IV

INSPECTION, MAINTENANCE AND SAFETY STUDIES $\frac{1}{1}$

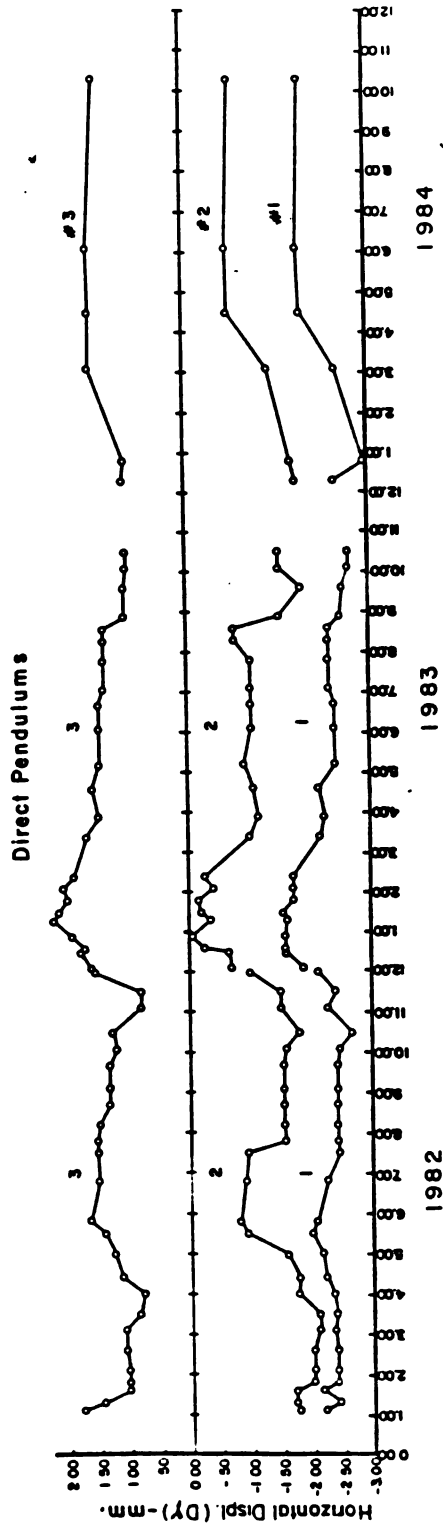
Figure 4.23 Direct pendulums transverse movement in 1982-1984.

There are six pendulums installed inside the dam to measure the movements of the dam. As shown by Figures 4.24 and 4.25 for "direct pendulum", the maximum movements for each pendulum was less than 2 millimeters between 1982 and 1984 and also in 1984 the pendulum readings were very stable. The No. 1 and No. 2 inverted pendulum fluctuated within 2 millimeters between 1982 and 1984. However, No. 3 inverted pendulum, inserted at Buttress Block 15, had moved considerably (about 4 mm) between March to July 1982 both in transverse and longitudinal directions. Figures 4.26 and 4.27 show the pendulum wire movements. One must note that No. 3 direct pendulum is also inserted at Buttress Block 15 and had not moved considerably between March to July 1982. This discrepancy should be investigated at once. It appears that the dam movements could certainly be caused by thermal stresses due to temperature fluctuations. In the future, its pendulum should move more than 5 mm which was the maximum movement recorded in the past four years, one must employ a specialist to investigate this matter. Fluctuation of readings within narrow limits are certainly better than progressing movements in one direction.
