ESTUDIOS SOBRE LA OPERACION Y SEGURIDAD DEL SISTEMA DE EMBALSES DE VALDESIA

SECOND TECHNICAL REPORT ^{1/}

VOLUME IV

INSPECTION, MAINTENANCE AND SAFETY STUDIES

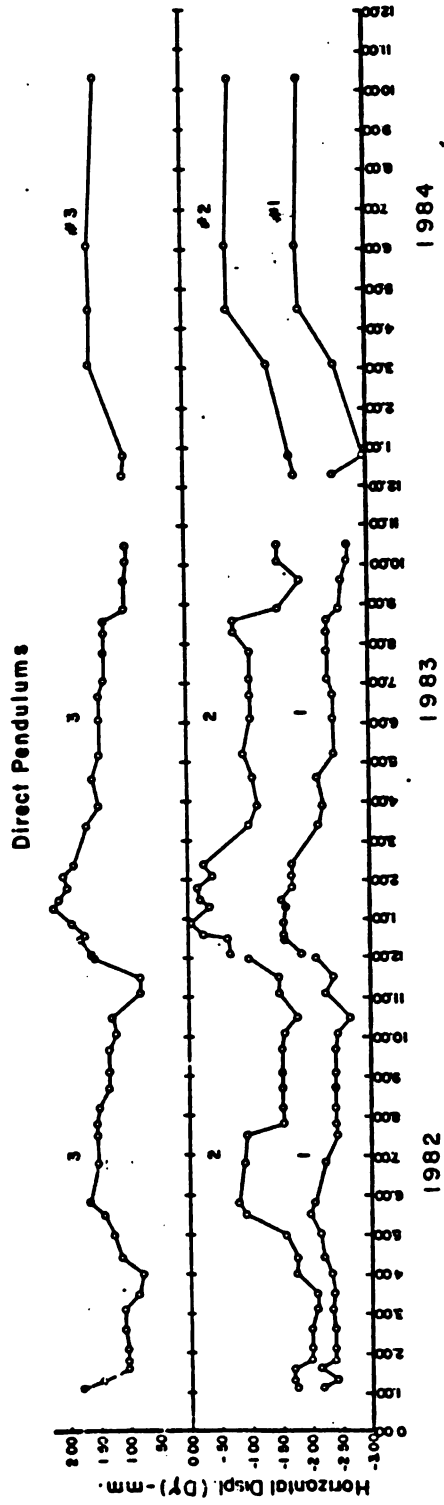
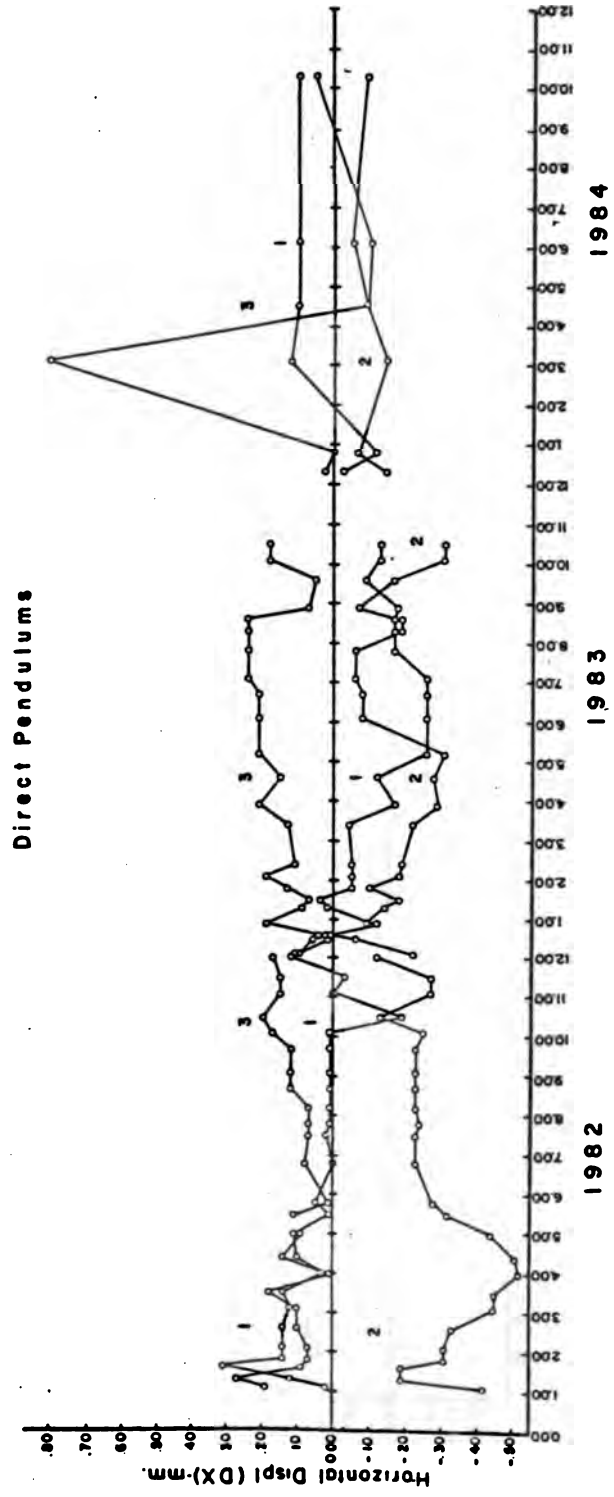
There are six pendulums installed inside the dam to measure the movements of the dam. As shown by Figures 4.24 and 4.25 for "direct pendulum", the maximum movements for each pendulum was less than 2 millimeters between 1982 and 1984 and also in 1984 the pendulum readings were very stable. The No. 1 and No. 2 inverted pendulum fluctuated within 2 millimeters between 1982 and 1984. However, No. 3 inverted pendulum, inserted at Buttress Block 15, had moved considerably (about 4 mm) between March to July 1982 both in transverse and longitudinal directions. Figures 4.26 and 4.27 show the pendulum wire movements. One must note that No. 3 direct pendulum is also inserted at Buttress Block 15 and had not moved considerably between March to July 1982. This discrepancy should be investigated at once. It appears that the dam movements could certainly be caused by thermal stresses due to temperature fluctuations. In the future, its pendulum should move more than 5 mm which was the maximum movement recorded in the past four years, one must employ a specialist to investigate this matter. Fluctuation of readings within narrow limits are certainly better than progressing movements in one direction.

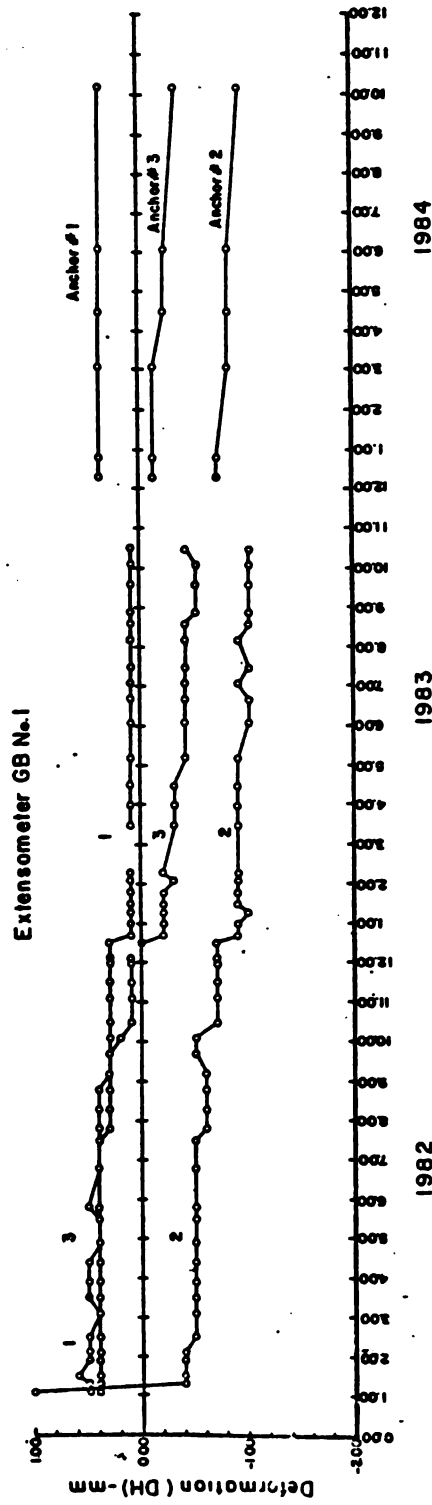
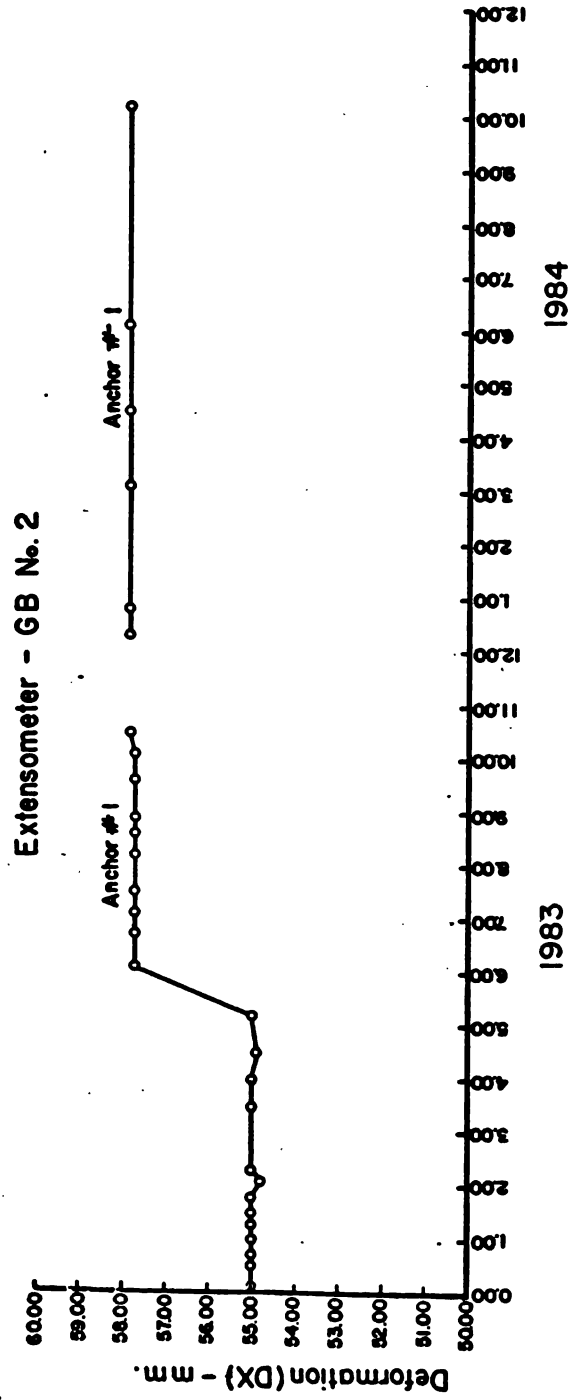
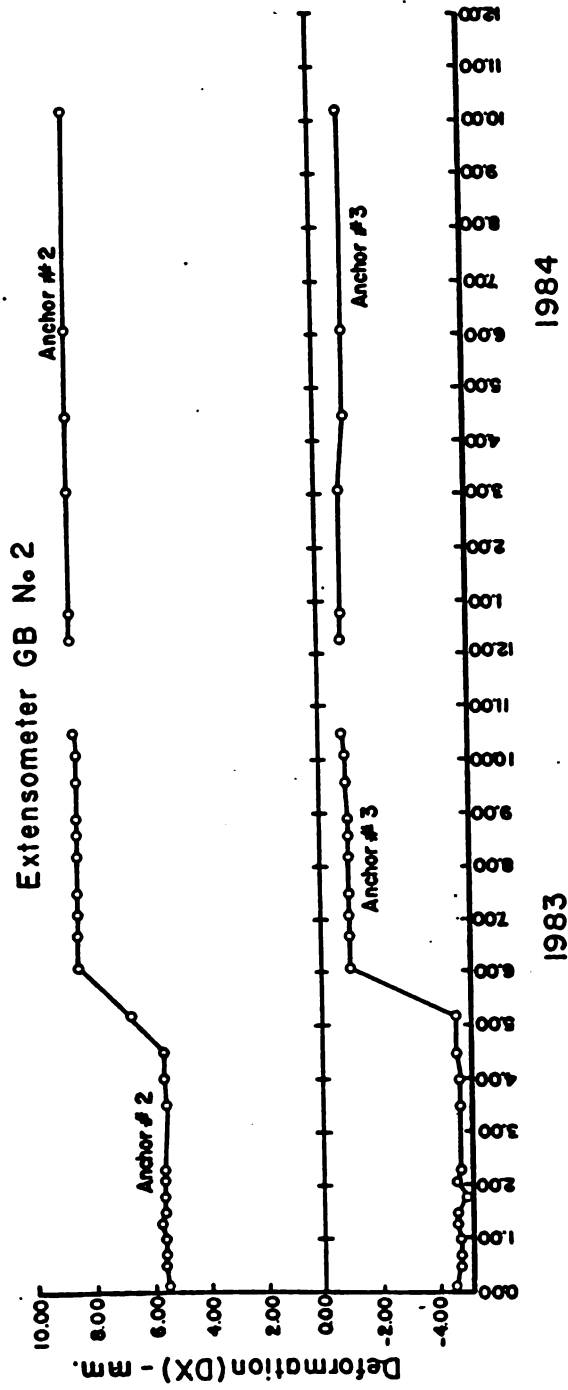
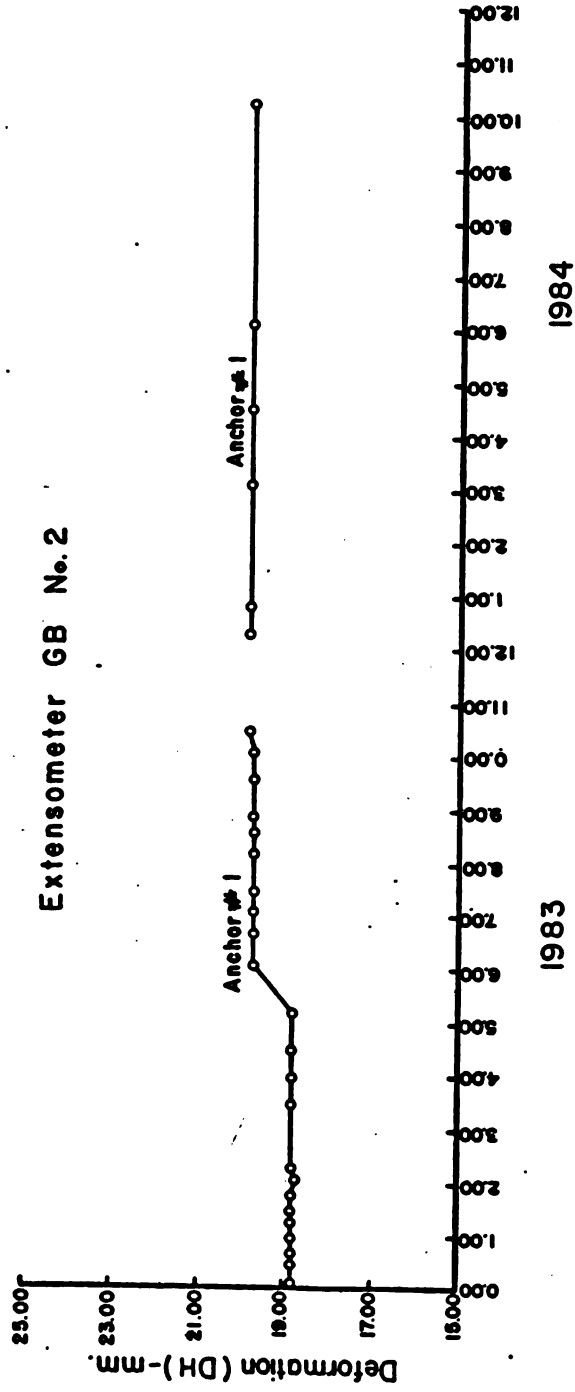
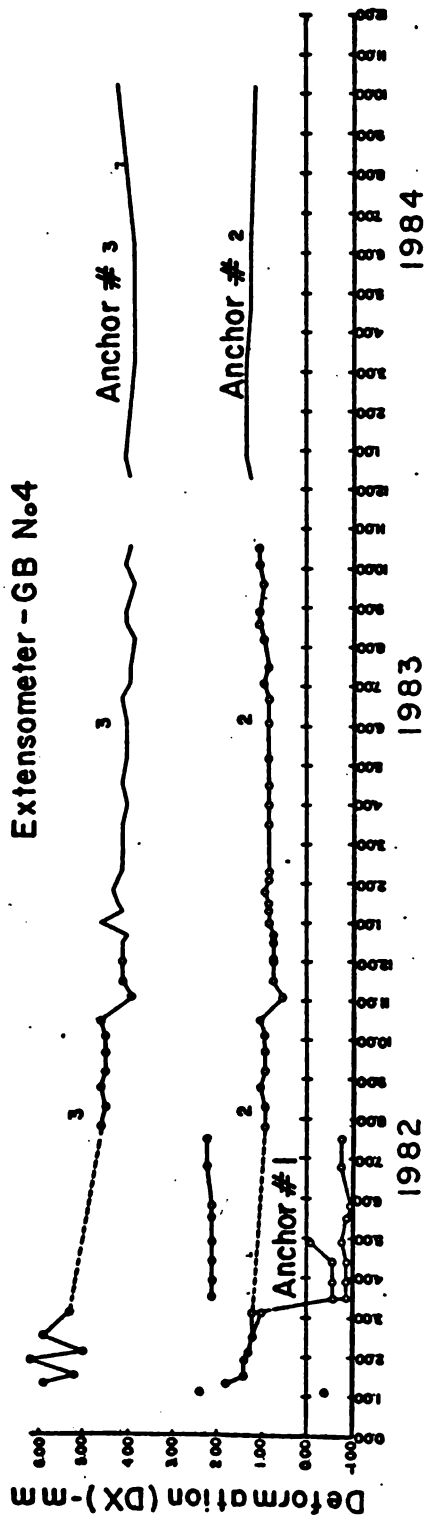
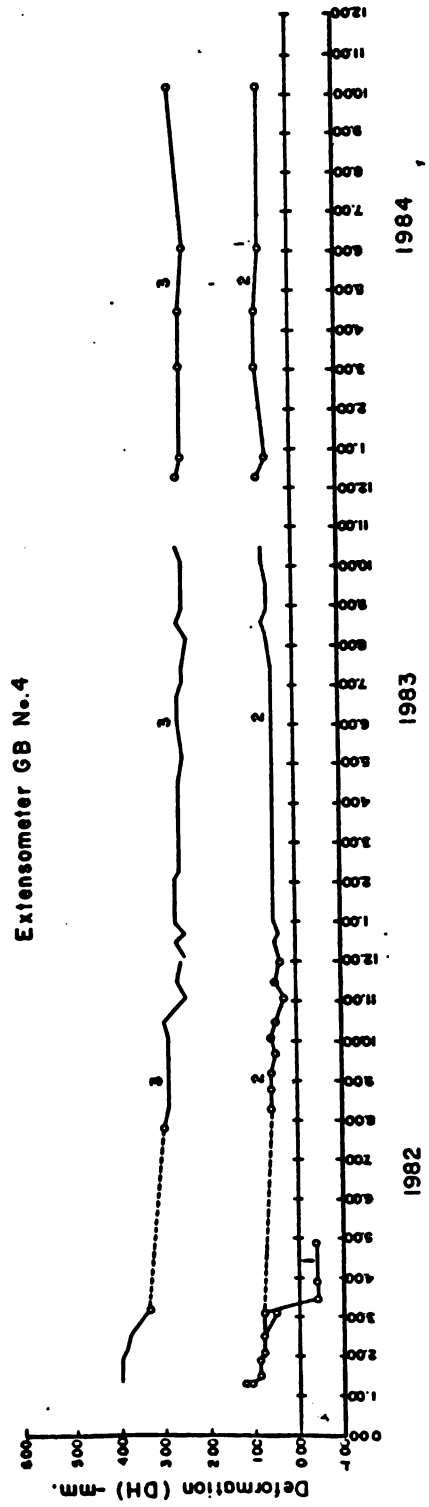
in bad shape during the flooding by Hurricane David and repairs were made for all these extensometers. Data collected during 1982, 1983 and 1984 are plotted in Figs 4-27 through 4-34 and summarized in Table 4.1.

As indicated in Table 4.1, the anchors in Base No. 1 moved within 1 mm; the anchors in Base No. 2 moved within 3 mm; the anchor in Base No. 3 moved within 0.5 mm and the anchor in Base No. 4 moved within 2 mm. These movements appear to be normal. Readings taken from extensometers Group No. 11 installed in the upstream face of dam shell near elevation 116 meters indicated that very little movements occurred between January 1982 and October 1983.
